TD-06-007

EDDY CURRENT SCANNING REPORT

FNAL-3RDHARMONIC CAVITIES #7-8

FNAL/Technical Division

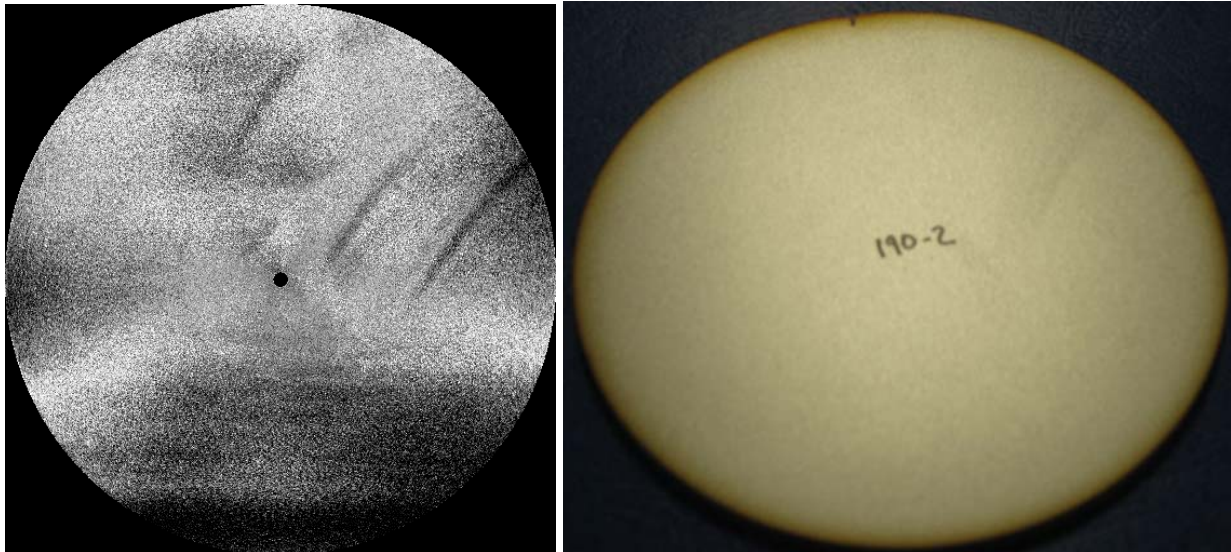
Disc 190 shows very particular types of signals on side 2. Interestingly these signals can be correlated with areas on the disc with a reflectivity that is different from the rest of the disc. Further analysis could not be performed because of a lack of time.

Figure 3: Eddy current scan (left) and photograph of disc 190-2.
